**Defective Groundwater Protection Practices at the Sandia National Laboratories’
Mixed Waste Landfill – The Sandia MWL dump.
- Version January 22, 2011**

Robert H. Gilkeson, Registered Geologist
PO Box 670
Los Alamos, NM 87544
rhgilkeson@aol.com

David B. McCoy, Executive Director
Citizen Action New Mexico
POB 4276
Albuquerque, NM 87196-4276
505 262-1862
dave@radfreenm.org

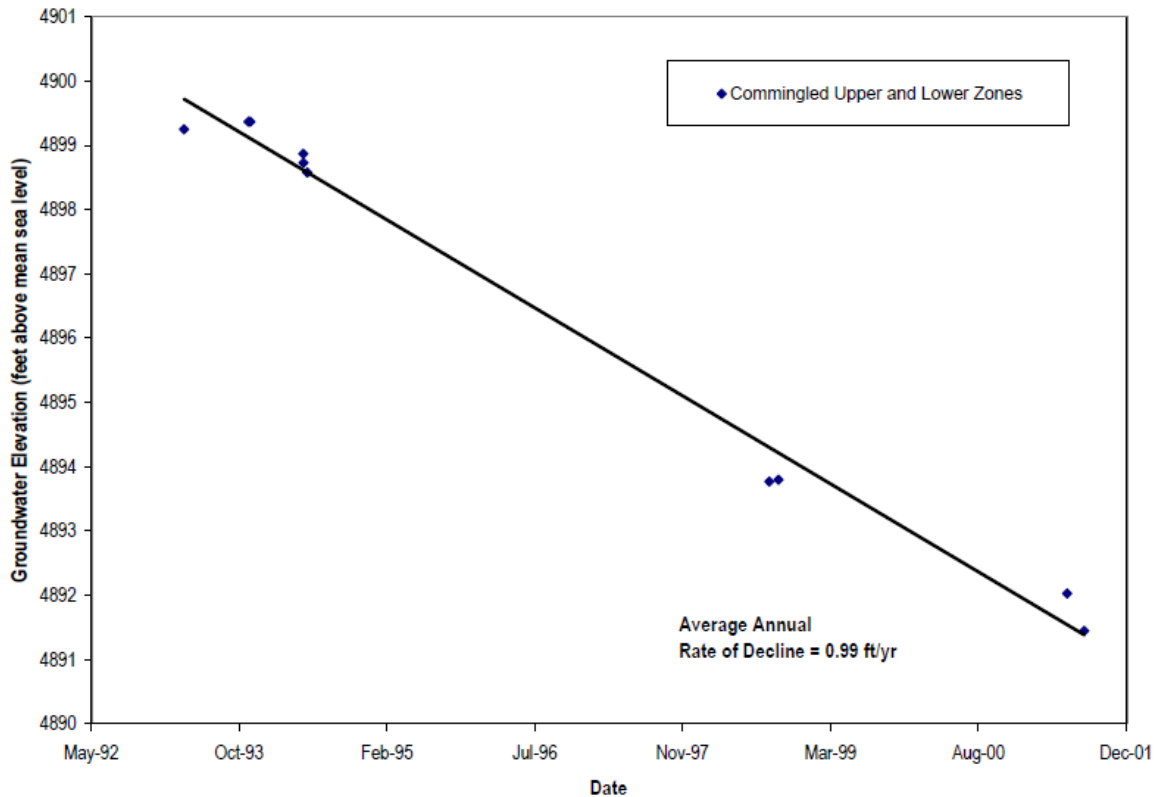
Figure 3-8. Hydrograph of Water Levels in MWL-MW4

For MW4, the majority of post-05/23/1994 groundwater sample data are derived from samples from the upper screen, which also samples the AF Facies [i.e., the fine-grained alluvial fan sediments]. However, data from earlier groundwater samples were composites of groundwater from both screens, with groundwater hydrochemistry from the lower more-conductive ARG facies presumably dominant (Goering, 09/21/2006).

More than 16 months passed after the installation of monitoring well MWL-MW4 before a packer was installed on May 23, 1994 to prevent the open flow of possibly contaminated groundwater from the upper screen to the lower screen. In addition, the figure below from the DOE/Sandia report by Goering et al. (2002)⁹ shows that the packer was removed from well MWL-MW4 for unknown periods of time in 1998 and 2001 because the figure describes the water levels measured in many years as “Commingled Upper and Lower Zones.”

Cross-contamination between different zones of saturation is not permissible under RCRA or the NMED Sandia Consent Order ¹. The long periods of groundwater flow between the upper and lower screen in well MWL-MW4 is an example of the failure of the NMED HWB to enforce the regulations and protect public health.

*The large rise of 3.69 feet for the water level measured on April 2, 2007 is evidence that leakage was occurring across the inflatable packer when the water level was measured on April 5, 2006.
