Defective Groundwater Protection Practices at the Sandia National Laboratories' Mixed Waste Landfill – The Sandia MWL dump.
- Version December 30, 2010

Robert H. Gilkeson, Registered Geologist
PO Box 670
Los Alamos, NM 87544
505 412-1930
rhgilkeson@aol.com

David B. McCoy, Executive Director
Citizen Action New Mexico
POB 4276
Albuquerque, NM 87196-4276
505 262-1862
dave@radfreenm.org

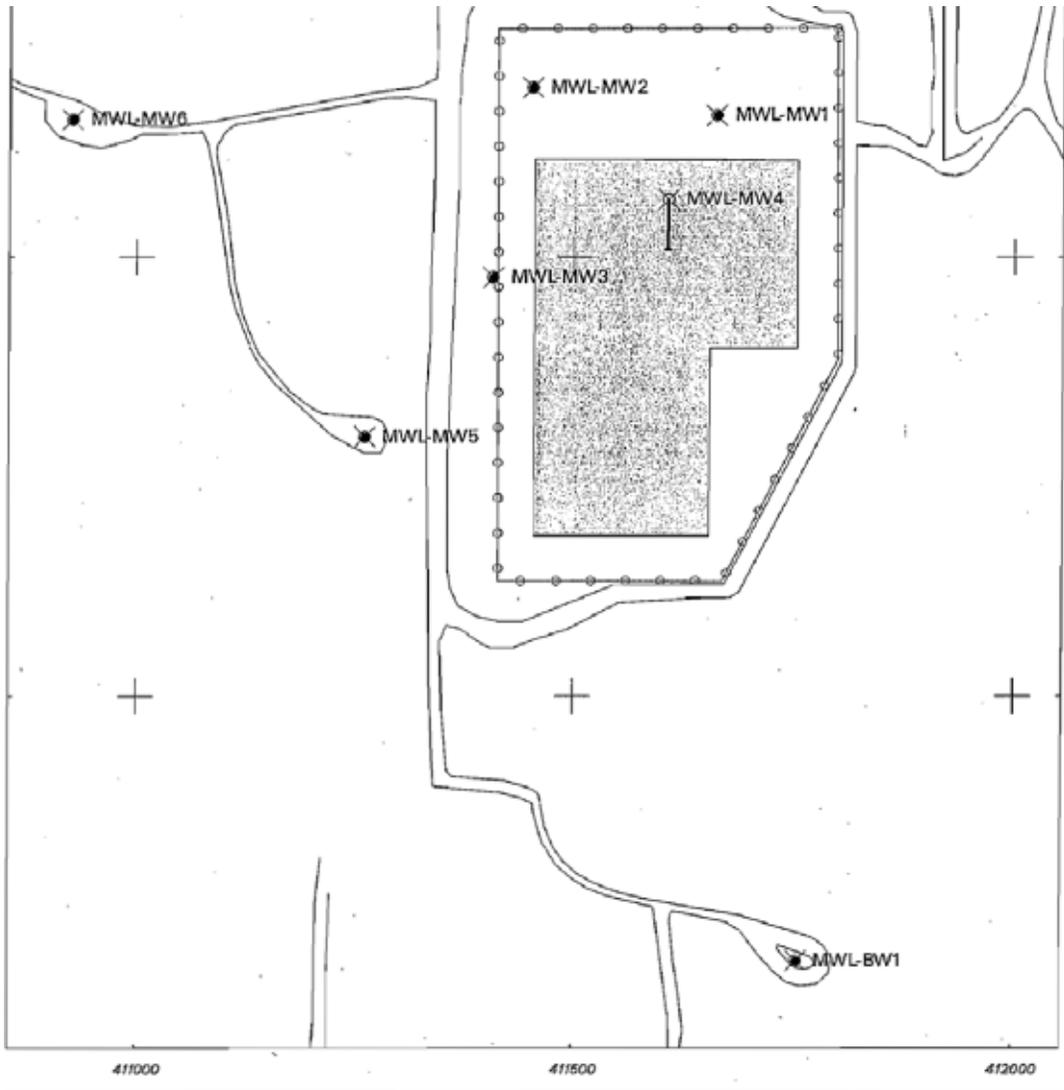
This review of the monitoring wells by Mr. Gilkeson and Citizen Action has determined that only two of the six contaminant detection monitoring wells displayed on Figure ES-2 (i.e., wells MWL-MW1 and -MW3) were at locations that could detect groundwater contamination from the Sandia MWL dump.

Figure ES-2. Map of the Sandia Mixed Waste Landfill (Sandia MWL dump) showing the monitoring well network in 2007 of the six monitoring wells MW1 to MW6 and the background water quality well BW1 500 feet south of the dump.

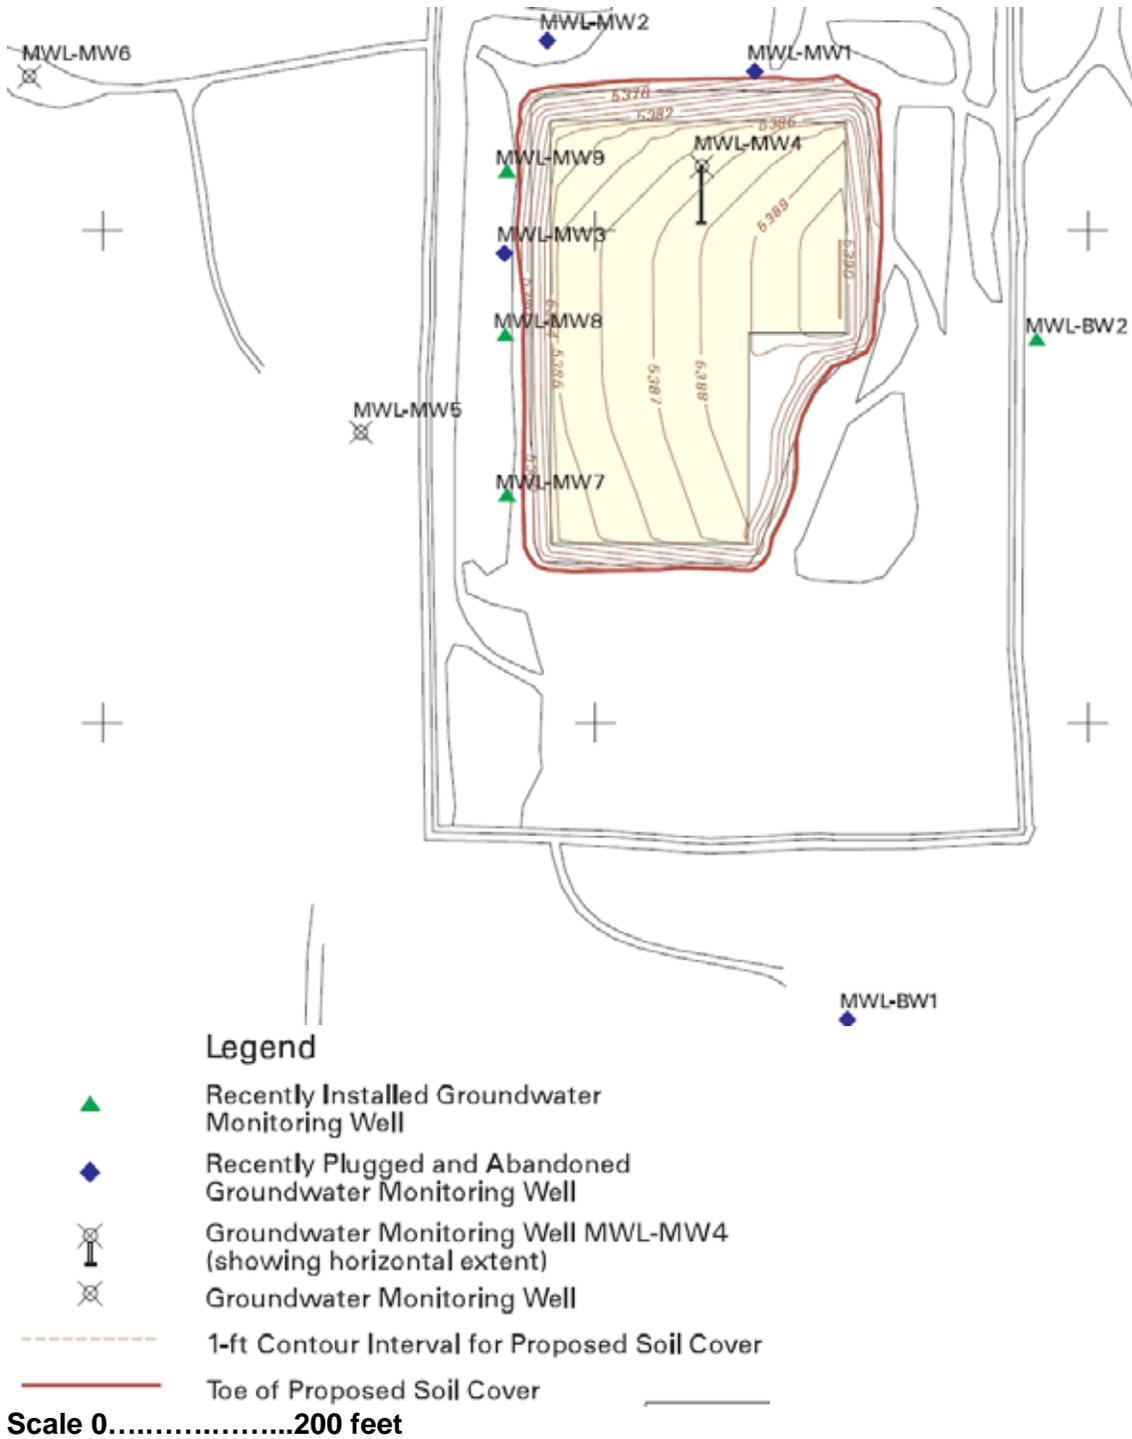
The NMED HWB has not, but should require replacement of the unreliable monitoring wells as is required by the April 29, 2004 Consent Order (p.63) for monitoring wells that do not serve their intended purpose. Figure ES-3 shows that the two unreliable monitoring wells MWL-MW5 and -MW6 are in the current network of monitoring wells. In addition, DOE/Sandia proposes to use the two unreliable monitoring wells that do not allow accurate assessment of groundwater contamination in the long-term monitoring and maintenance plan for the MWL dump (DOE/Sandia, 2007).

The water levels measured in the three new monitoring wells installed in 2008 (wells MWL-MW7, -MW8, and -MW9) are approximately 20 feet below the known elevation of the water table along the western side of the MWL dump. The erroneous deep water levels measured in the three new monitoring wells are because of mistakes that include: 1). use of the incorrect air-rotary casing hammer (ARCH) drilling method, 2). the improper drilling operations and 3). the 30-foot long well screens in noncompliance with the 10 foot limitation to prevent sample dilution and inaccurate water level measurements, as required by the EPA (US EPA, 1992) and the NMED Sandia Consent Order. The mistakes are because the NMED HWB did not enforce the requirements in the NMED Sandia Consent Order for 1). drilling method, 2). drilling operations and 3). well design.

Figure ES-3. Location of the new detection monitoring wells MWL-MW7, -MW8 and -MW9 along the western boundary of the Sandia MWL Dump and the new background monitoring well MWL-BW2 200 feet east of the MWL Dump. The four new monitoring wells were installed in 2008.

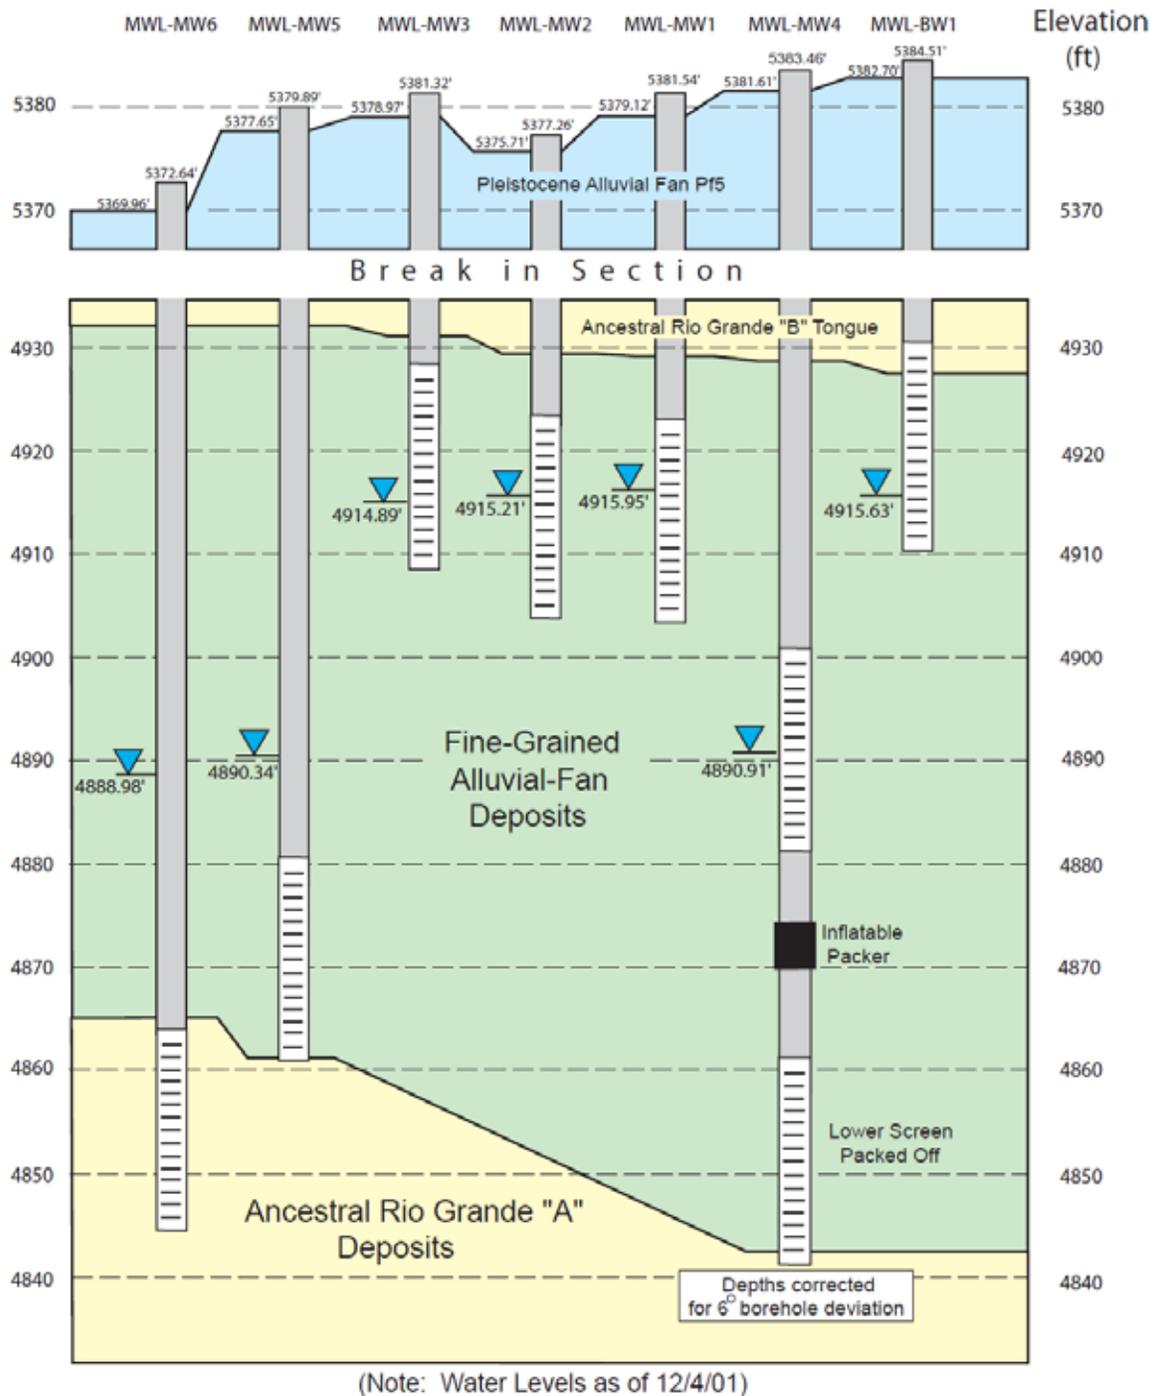
The installation of the upper screen in well MWL-MW4 too deep below the water table is displayed on Figure ES-4. The NMED has not, but should require replacement of the defective monitoring well. Many DOE/Sandia reports present the unreliable water quality data collected from the defective well MWL-MW4 for the incorrect conclusion that the MWL dump has not contaminated the groundwater below the Sandia MWL dump.

As described above, Figure ES-4 shows that the screens in wells MWL-MW4, -MW5, and -MW6 are installed too deep below the water table. The three defective wells require replacement. The NMED HWB has not enforced the requirement in the Sandia Consent Order, the 1998 NMED NOD Report and RCRA for replacement of the three defective monitoring wells.

Figure ES-4. Schematic of the Monitoring Wells and the Hydrogeologic Setting at the Sandia MWL dump. The permeable sands and gravels in the Ancestral Rio Grande "A Deposits (ARG deposits) are the valuable groundwater resource for Albuquerque and the surrounding region.

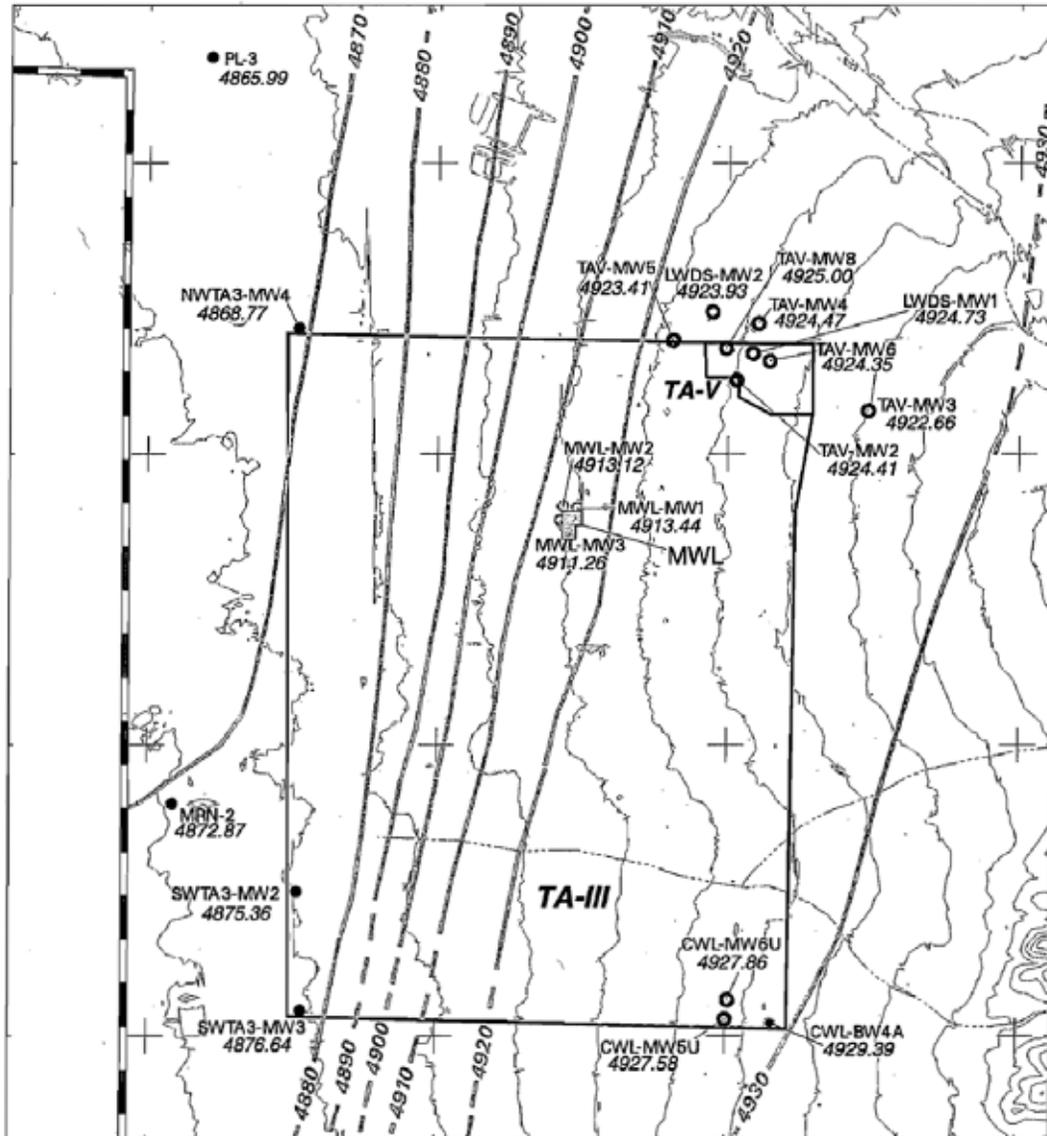
Figure ES-5. The regional water level contour map in the *Sandia 2008 Mixed Waste Landfill Annual Groundwater Monitoring Report*. The map incorrectly shows the direction of groundwater travel below the MWL dump is to the northwest. The MWL dump is at the center of the figure.

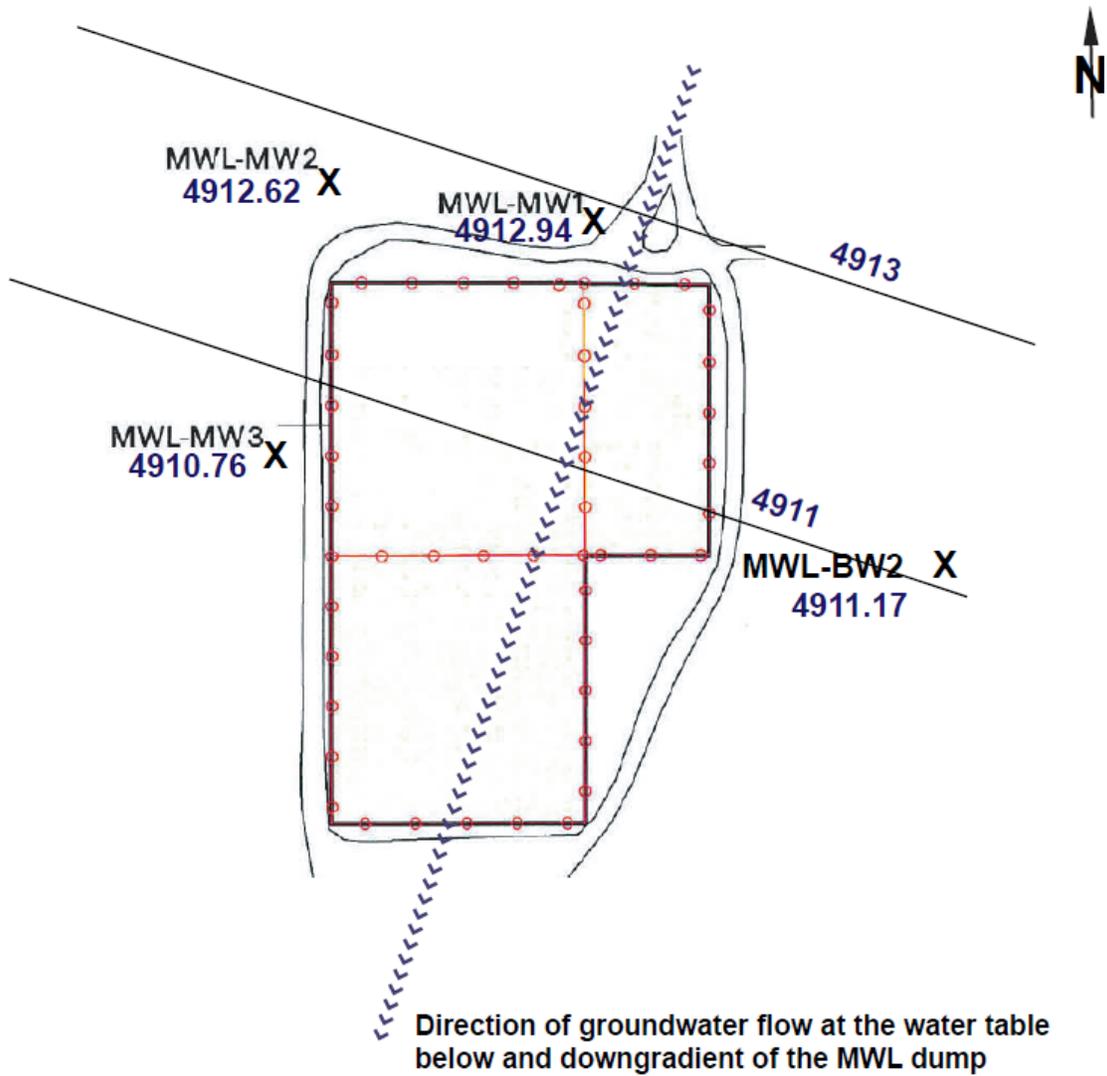
Figure ES-6. Water table contour map for the southwest direction of the groundwater flow at the water table below the Sandia MWL dump.

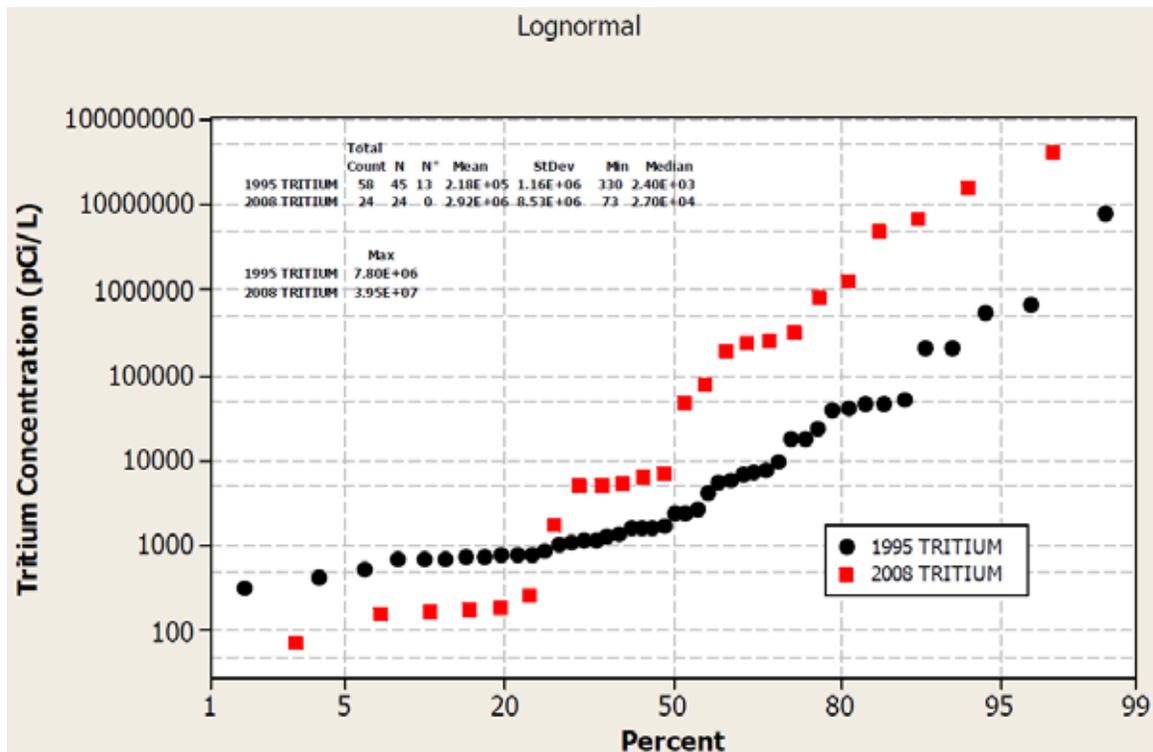
Figure ES-7. Comparison of 1995 and 2008 Tritium sediment sample analytical results for the 10-, 30- and 50-foot depth samples at the Sandia MWL dump.

- 7,800,000 pCi/L = Maximum Tritium Concentration in 1995 Sediment Samples
- 39,500,000 pCi/L = Maximum Tritium Concentration in 2008 Sediment Samples
- 3,900,000 pCi/L = Expected Maximum Tritium Concentration in 2008 Sediment Samples
