**ALBUQUERQUE'S ENDANGERED AQUIFER --
SANDIA NATIONAL LABORATORIES MIXED WASTE LANDFILL**

By
David B. McCoy, Esq.
Executive Director
Citizen Action New Mexico
dave@radfreenm.org
PO BOX 4276
ALBUQUERQUE, NM 87196
(505) 262-1862

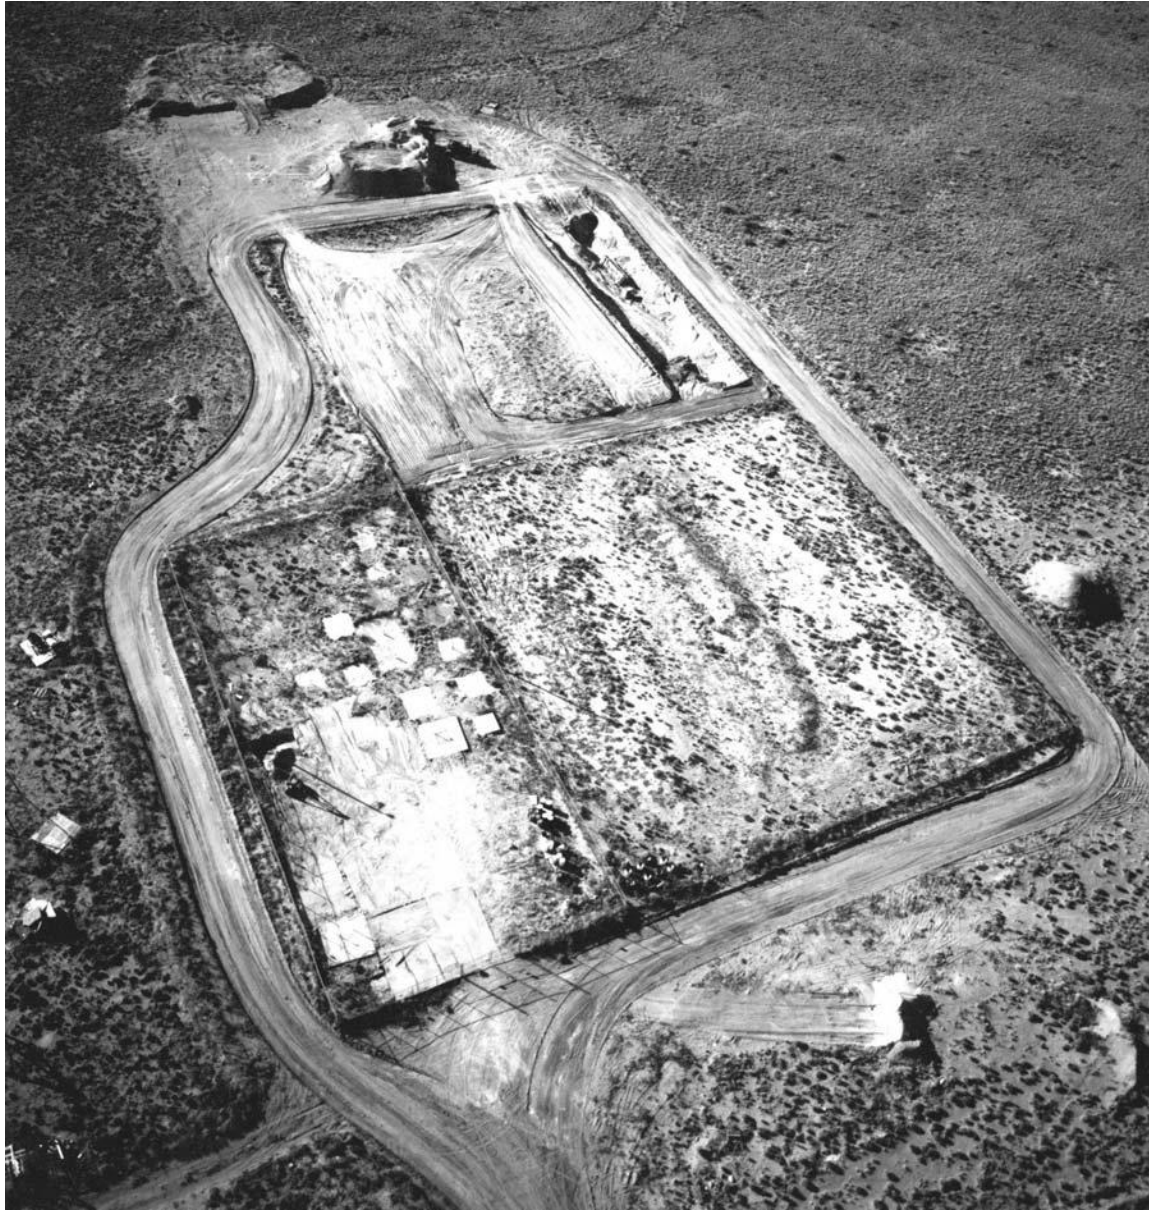
Figure 3. Aerial view of Sandia MWL dump looking to southwest in 1987. Trench F in the southwestern part of the Unclassified Area is open.

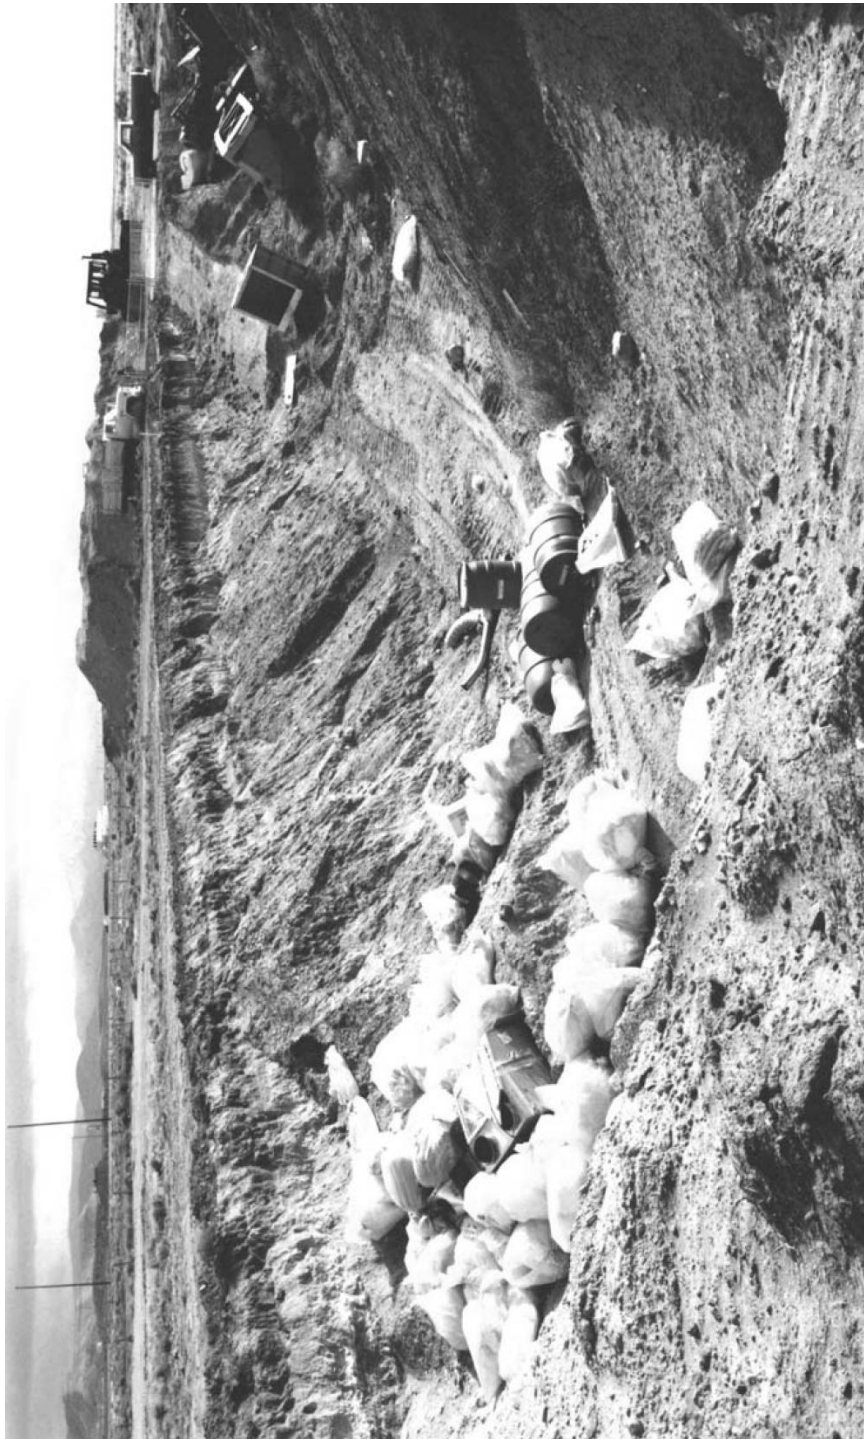
The MWL dump has an estimated 1,500,000 cu ft of radioactive and mixed hazardous wastes from making nuclear weapons. *Sandia officials cannot fully say what is really in the MWL dump. The wastes lie above Albuquerque's drinking water aquifer in plastic bags, cardboard boxes and steel drums* (See figures 4 and 5).

Figure 4. View of wastes dumped into unlined Trench F in the Unclassified Area of the Sandia MWL dump. Picture in 1987 with view looking south.

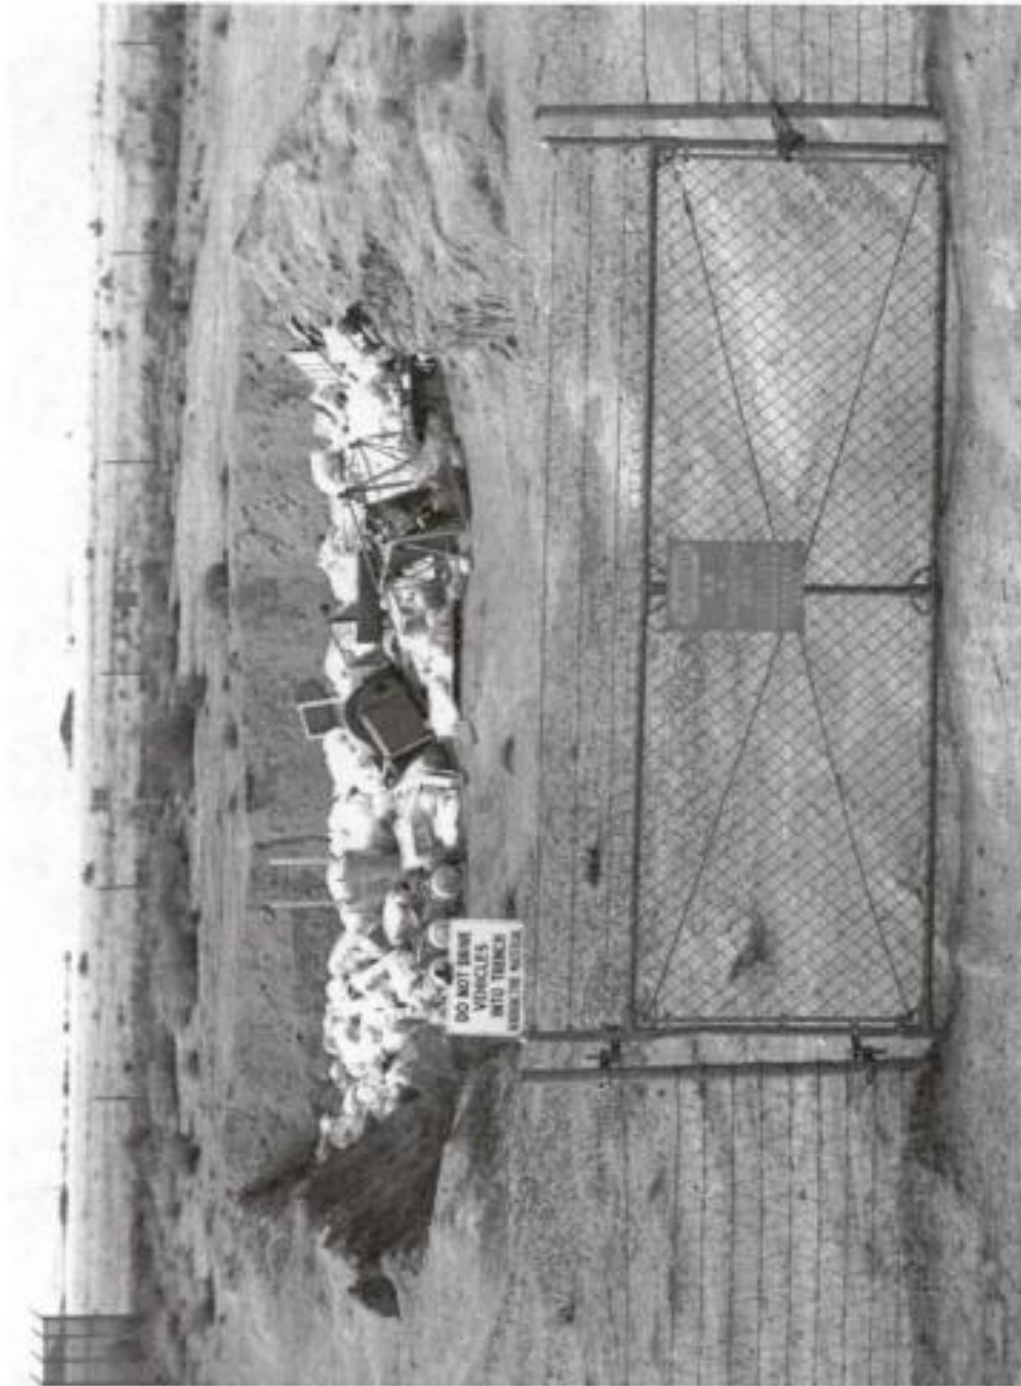
Figure 5. View of wastes dumped into unlined Trench D in the Unclassified Area of the Sandia MWL dump. Picture in 1966 with view looking south.

NOTE: In 1967 270,000 gallons of reactor coolant waste water was disposed of into the wastes dumped into Trench D as of 1966.

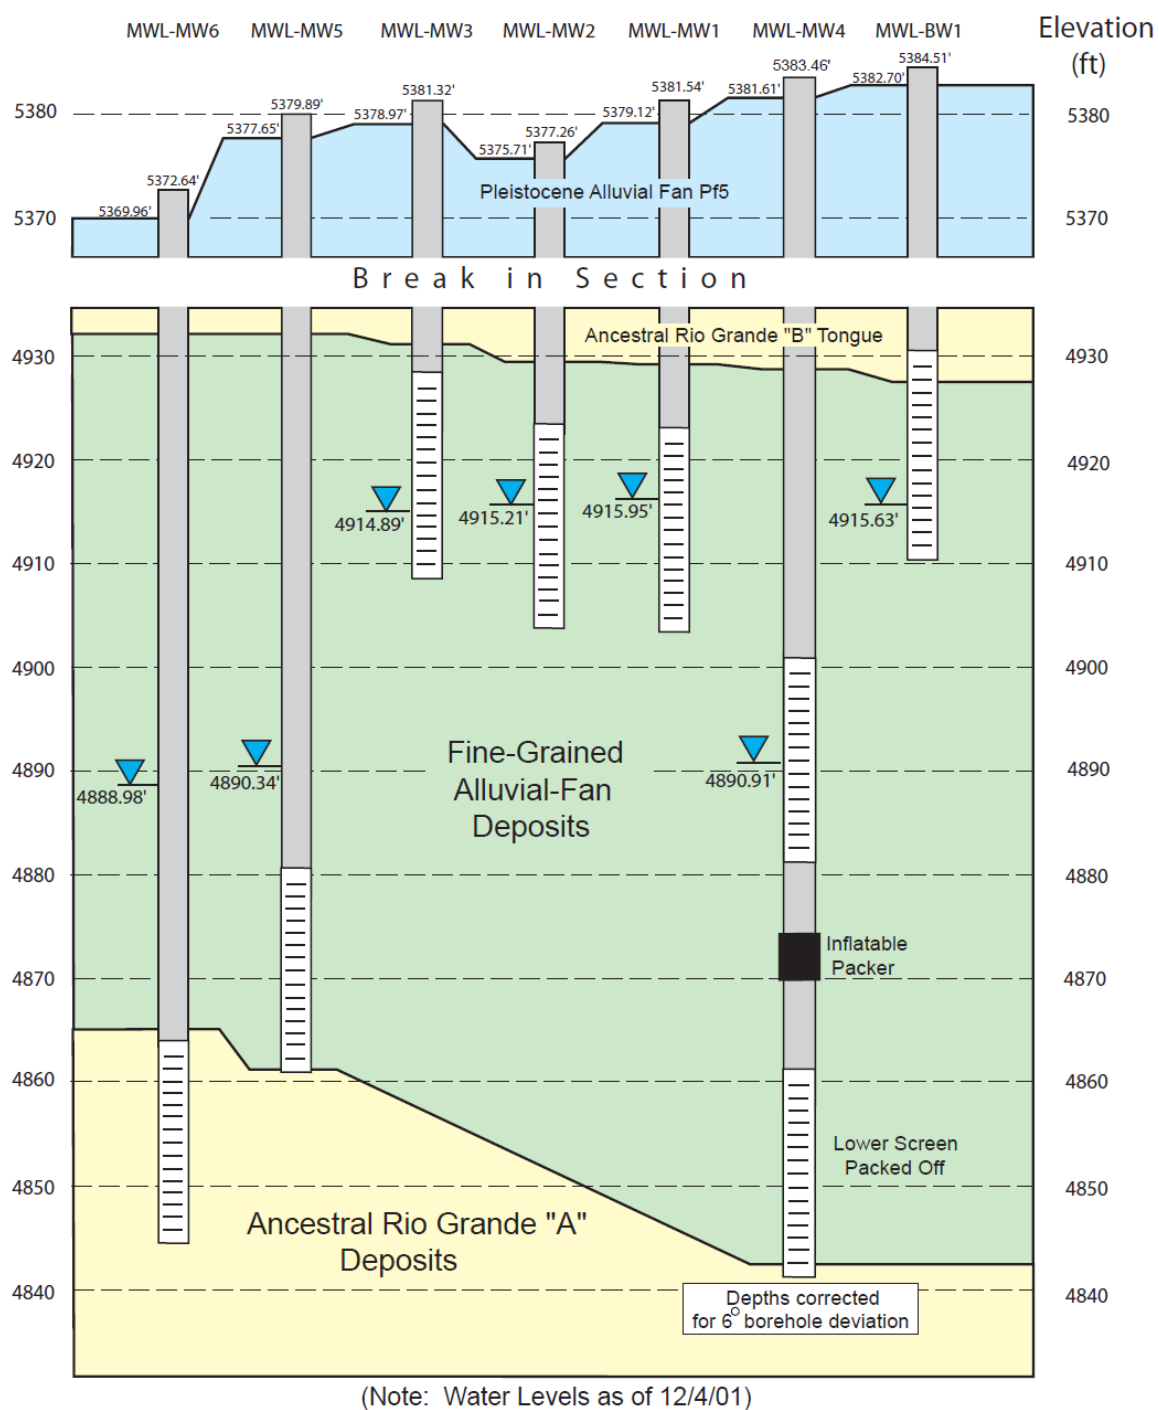
Figure 6. Schematic of the Monitoring Wells and the Hydrogeologic Setting at the Sandia MWL dump. The permeable sands and gravels in the Ancestral Rio Grande "A Deposits (ARG deposits) are the valuable groundwater resource for Albuquerque and the surrounding region.

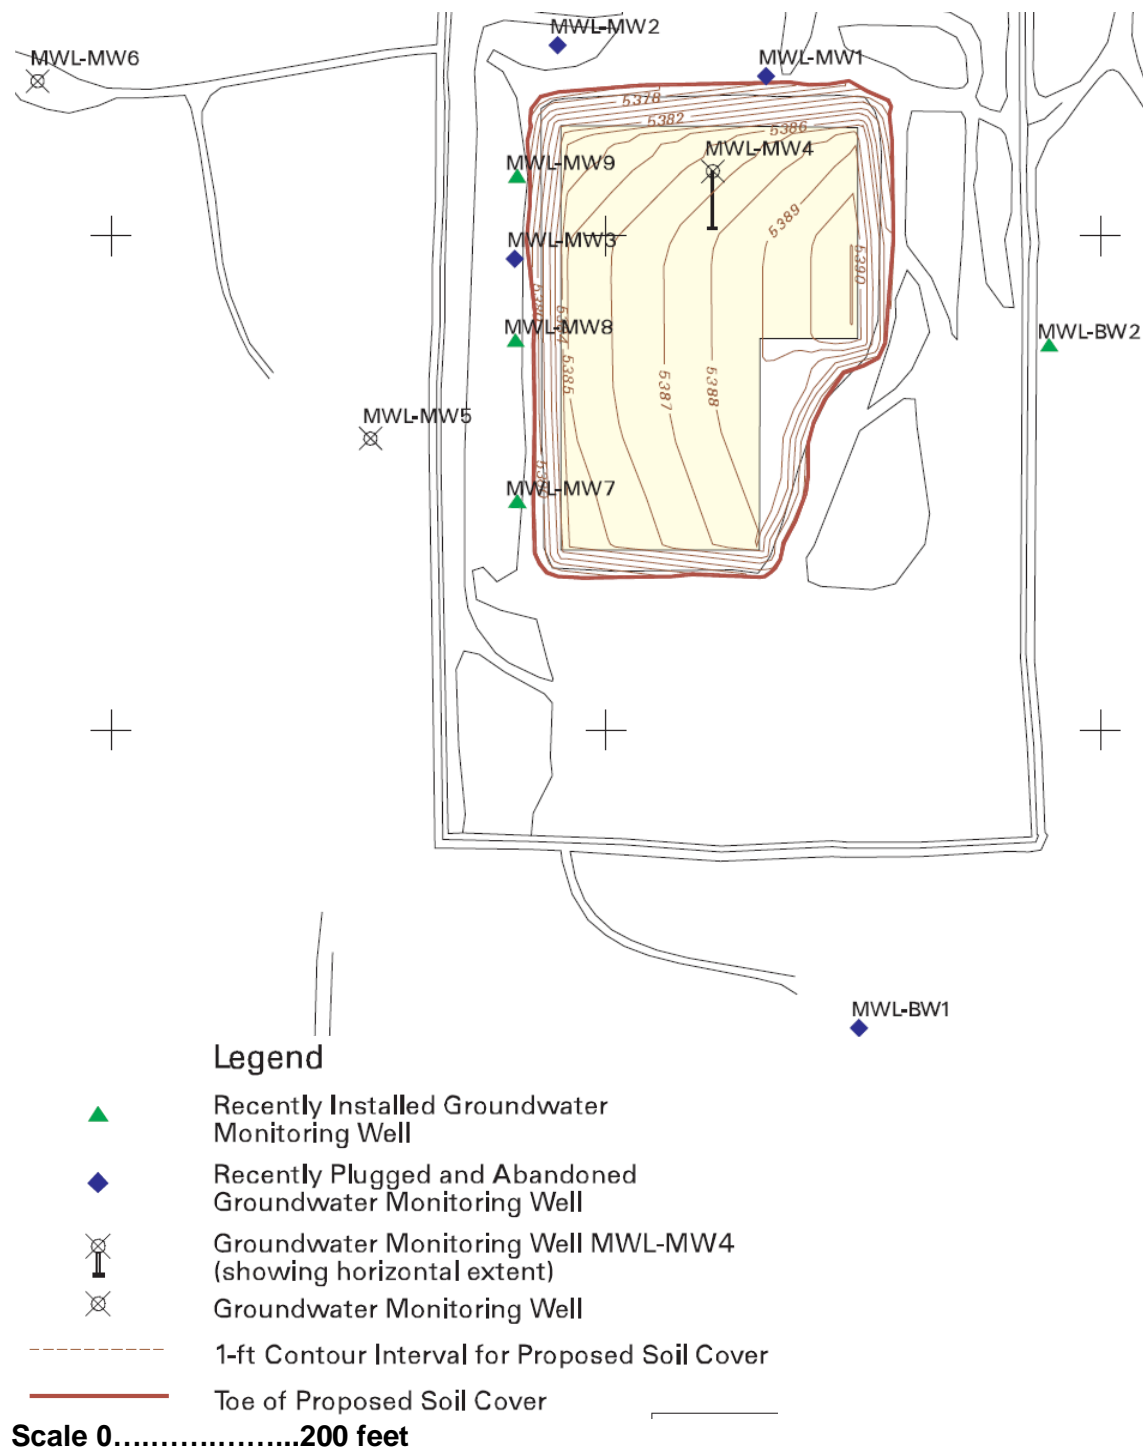
New wells installed in 2008 are too deep to monitor at the water table level for detection of contamination. The well screens are too long at 30 feet. The sampling is done improperly. Sandia, EPA and the NMED know that data from the well monitoring network is highly flawed. Nevertheless, Sandia continues to submit the false data, NMED continues to accept the false data for decisions and EPA continues to withhold its reports from the public.

Figure 7. Location of the eleven monitoring wells installed at the Sandia MWL dump over the years 1988 to 2008. The first four monitoring wells (MWL-MW1, -MW2 -MW3 and -

BW1 were installed in 1988 – 1989. The four new monitoring wells MWL-MW7, -MW8, -MW9 and -BW2 were installed in 2008.

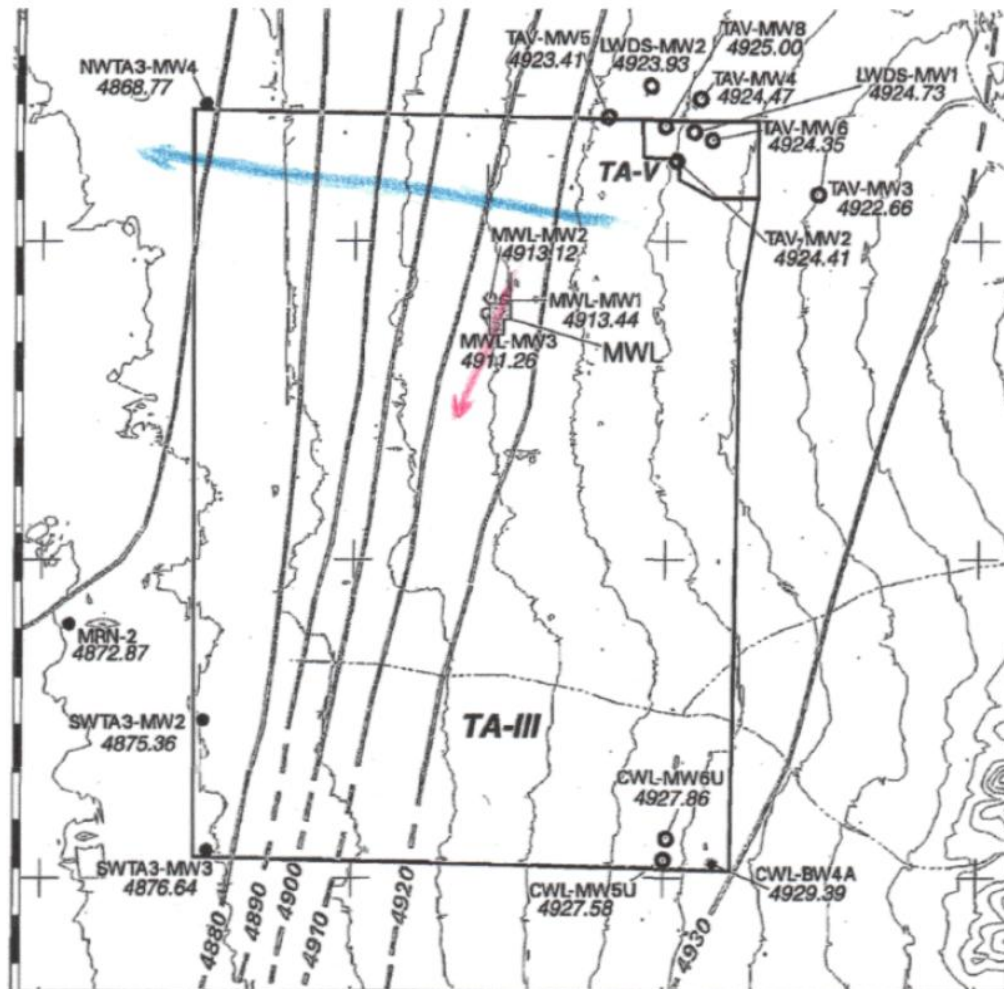
Figure 8. The regional water level contour map in the *Sandia 2008 Mixed Waste Landfill Annual Groundwater Monitoring Report*. The map incorrectly shows the direction of groundwater travel below the MWL dump is to the northwest. The MWL dump is at the center of the figure.

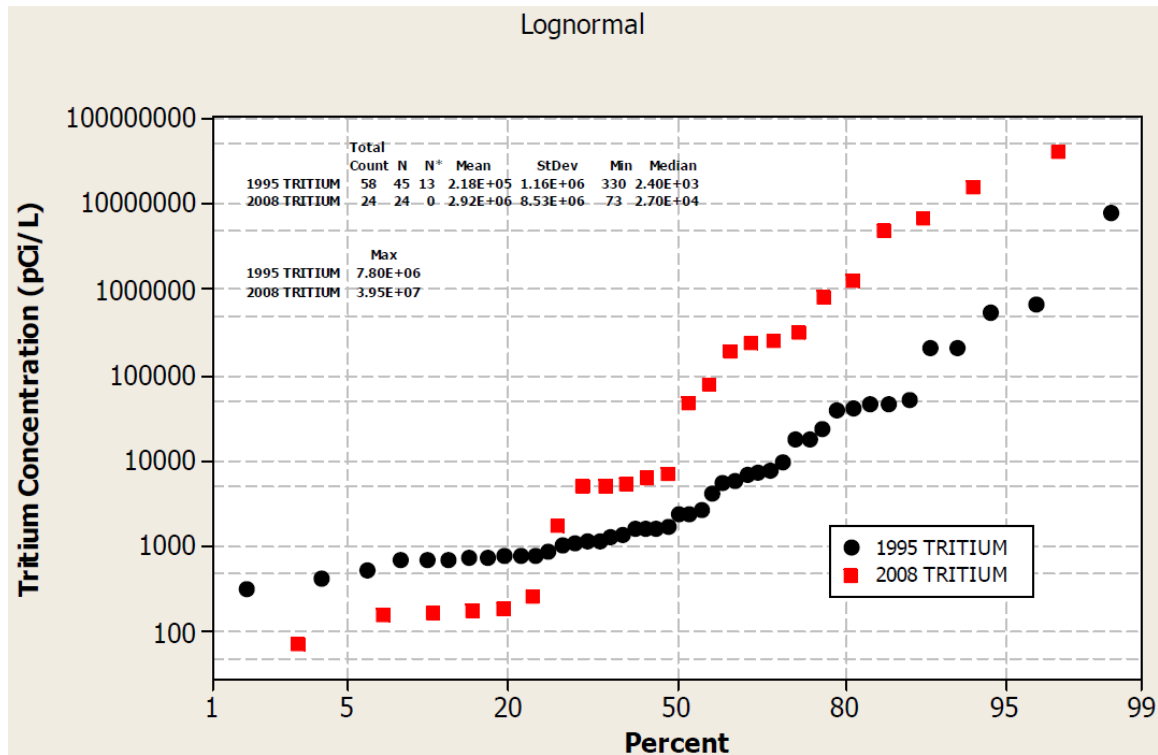
Figure 9. Comparison of 1995 and 2008 Tritium sediment sample analytical results for the 10-, 30- and 50-foot depth samples at the Sandia MWL dump.

- An enlarged view of the Tritium Maximum Concentration Data posted on the above figure is below:
- 7,800,000 pCi/L = Maximum Tritium Concentration in 1995 Sediment Samples
- 39,500,000 pCi/L = Maximum Tritium Concentration in 2008 Sediment Samples
- 3,900,000 pCi/L = Expected Maximum Tritium Concentration in 2008 Sediment Samples

Note: The half-life of tritium is 12.3 years. Therefore, the maximum tritium concentration measured in the 2008 soil samples was expected to be 50% less than the maximum value measured 13 years earlier in 1995. The maximum value expected to be measured in the 2008 study was approximately 3,900,000 pCi/L.

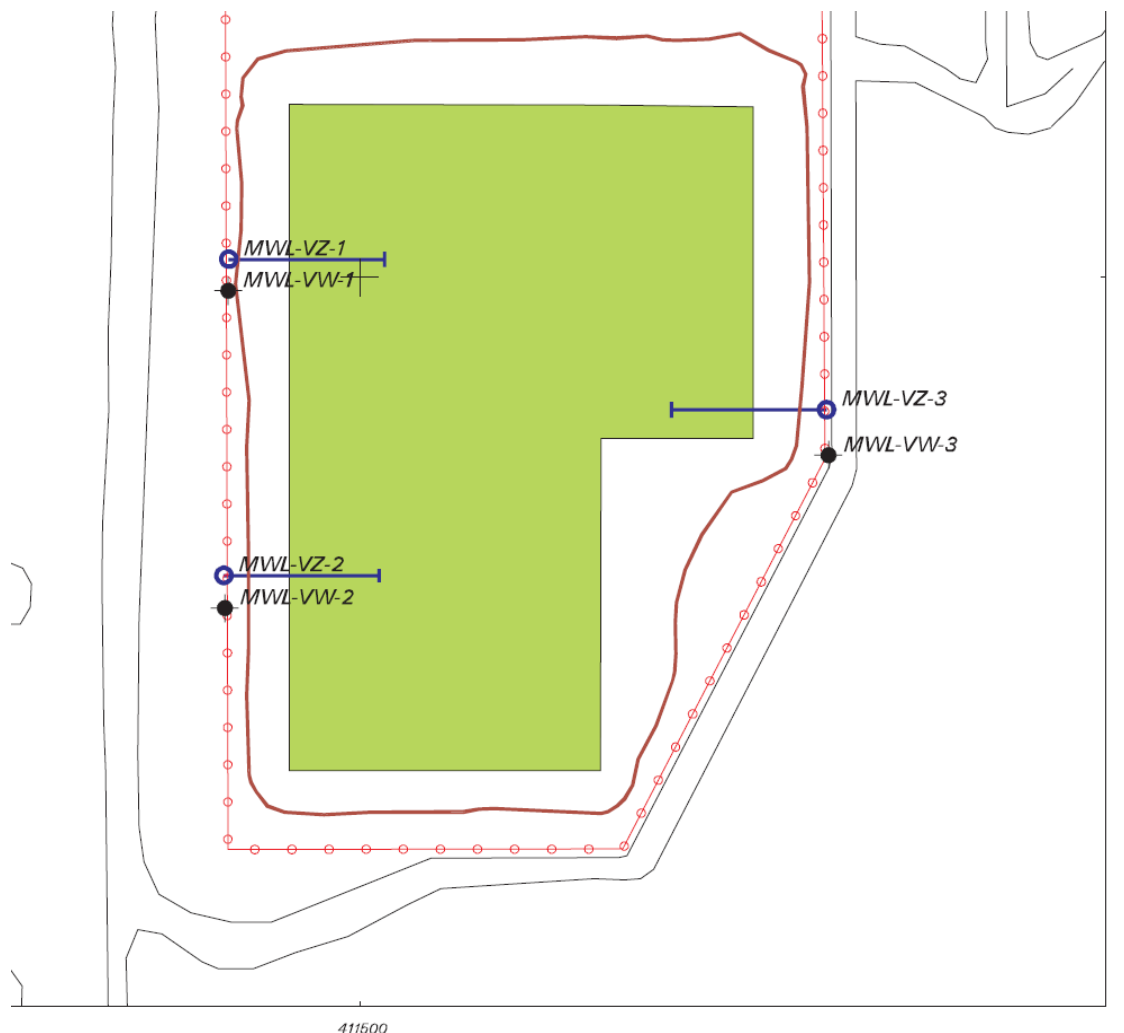
Figure 10. The proposed locations for three vadose zone monitoring wells and the three existing soil-moisture monitoring tubes at the Sandia MWL dump.

Note: The three proposed vertical vadose zone monitoring wells are MWL-VW1, MWL-VW2 and MWL-VW3. The three existing soil-moisture monitoring tubes installed at an angle below the MWL dump are MWL-VZ1, -VZ2 and -VZ3.
